# Tatum Consulting & Management, LLC

Hotel Churchill Construction Status Report  
For the San Diego Housing Commission  
December 9, 2009

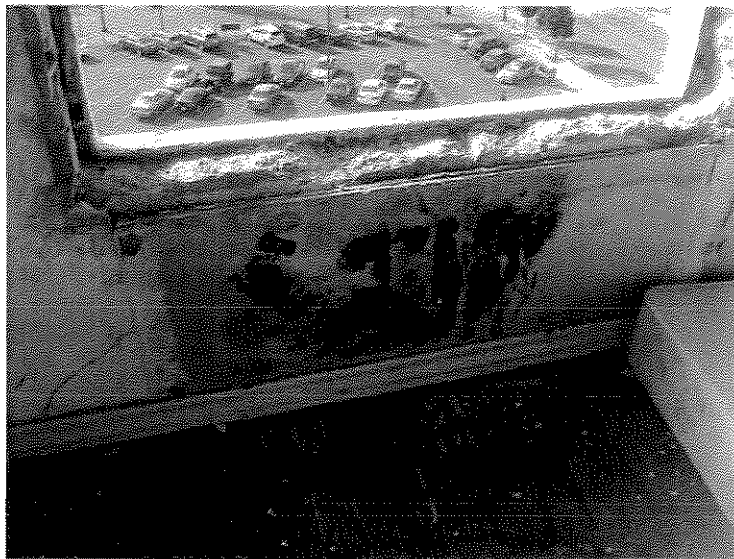
The Owner has provided a Hazardous Materials Report (Exhibit I), indicating the removal of a small amount of asbestos containing ceiling and floor material on the first floor. **In addition to this material and prior to final drywall completion, it is recommended that the Owner have a Mold Report commissioned. The building has had some of its windows removed for several months and mold has begun to grow in some locations on the walls. Photos of these areas may be seen at the end of the report.**

Mold on drywall at exterior wall.

3. *It is advised that the Owner hire a mold remediation firm to test the building and remove any mold that has formed over the last several months, due to the lack of many windows in the building. This should cost approximately \$10,000. The Owner has adequate funds in their proposed budget to cover these costs.*

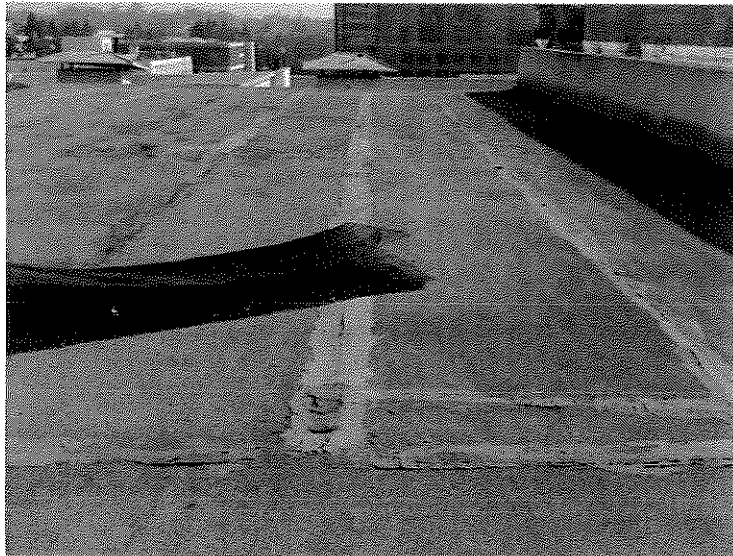
Existing flat roof (to be replaced)

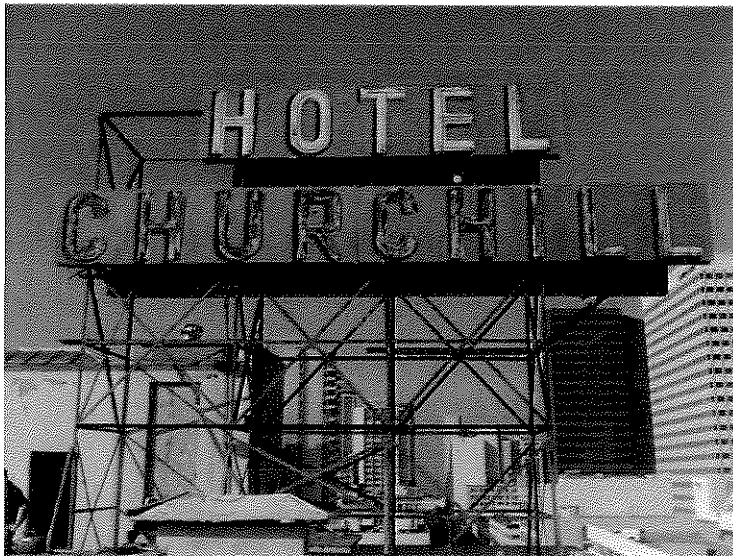
Rooftop sign (to be refurbished)

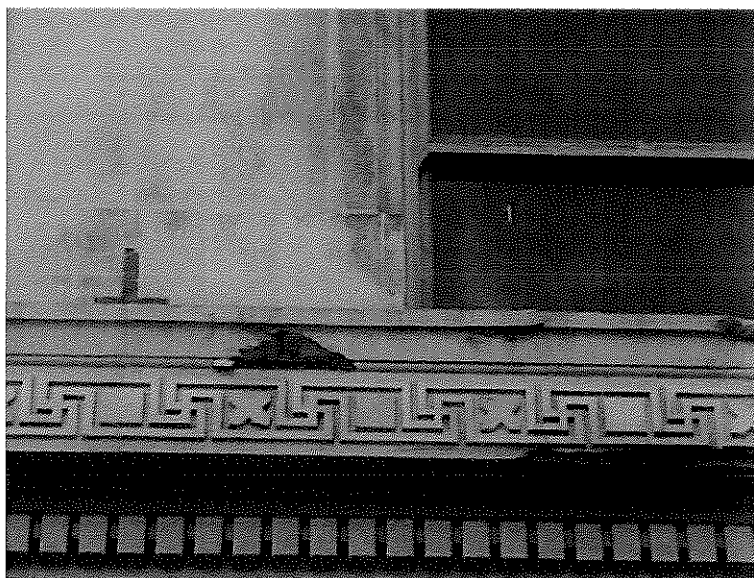
Exterior elevation showing stucco repair required.

- Removal and installation of all new windows throughout building. Approximately 130 new windows. Refurbishment of existing windows to remain.
- Removal of existing exterior color coat on entire building, patching of existing cracks and chips to the exterior building facade and the installation of a new color coat to meet historical board standard.

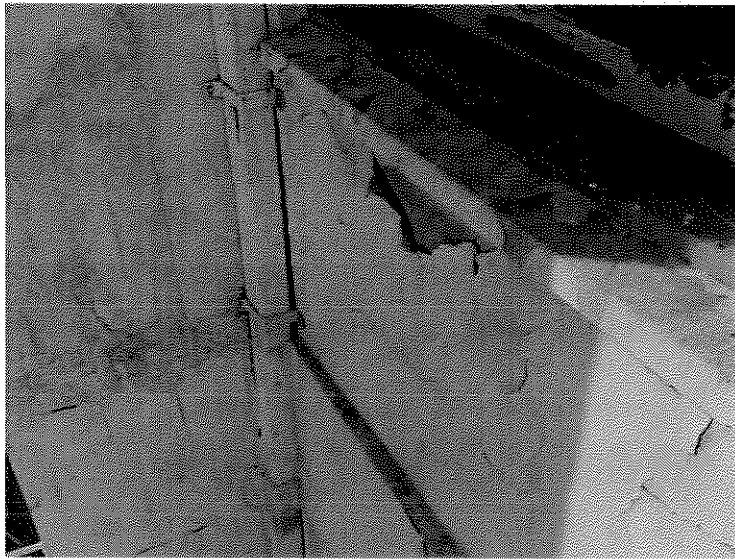
Exterior elevation showing peeling paint/stucco.

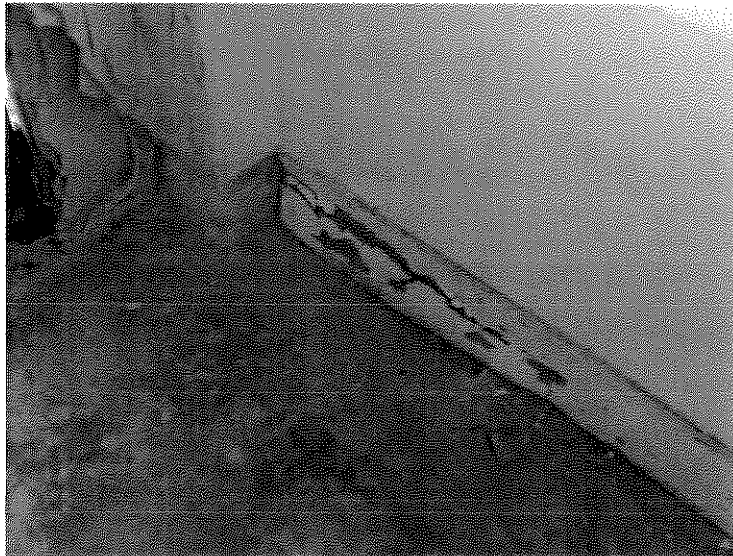
Typical unit rotted baseboard.

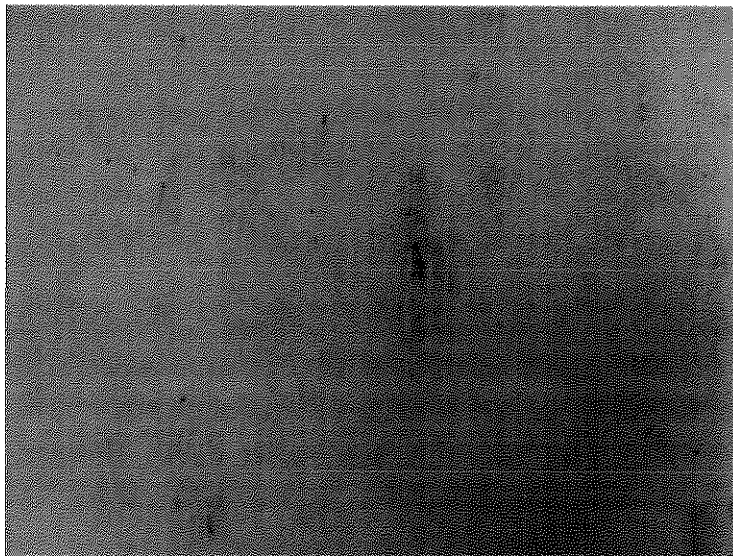
Signs of mold on drywall in unit.
