# Tatum Consulting & Management, LLC

Hotel Churchill Construction Status Report  
For the San Diego Housing Commission  
December 9, 2009

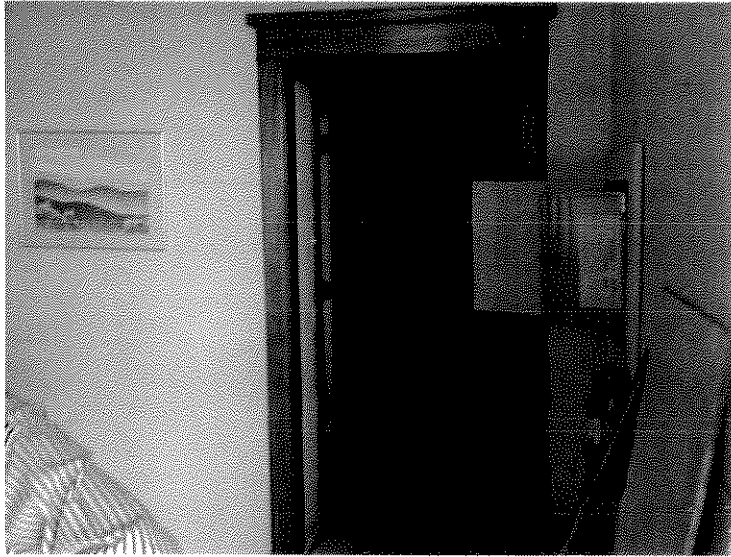
Typical hotel corridor

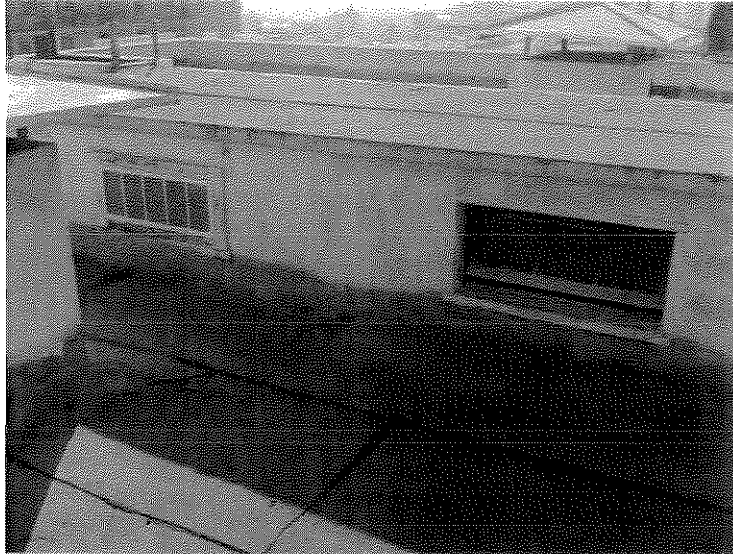
Elevator over ride at roof

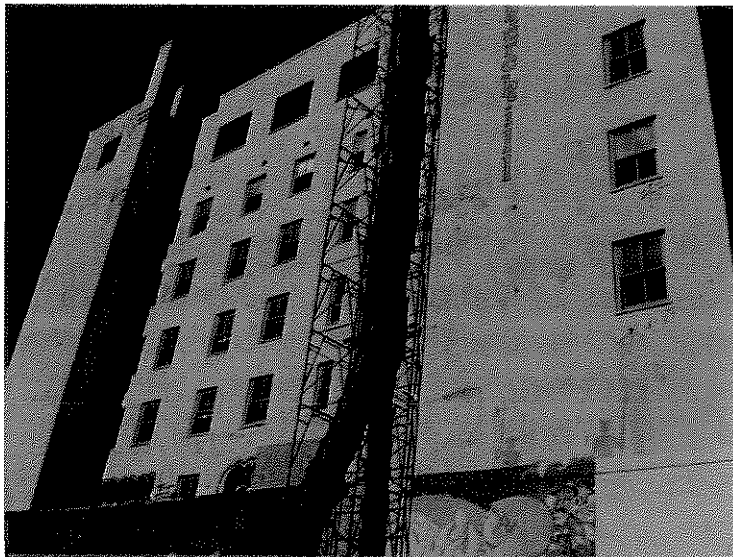
Exterior elevation of rear building showing trash chute.

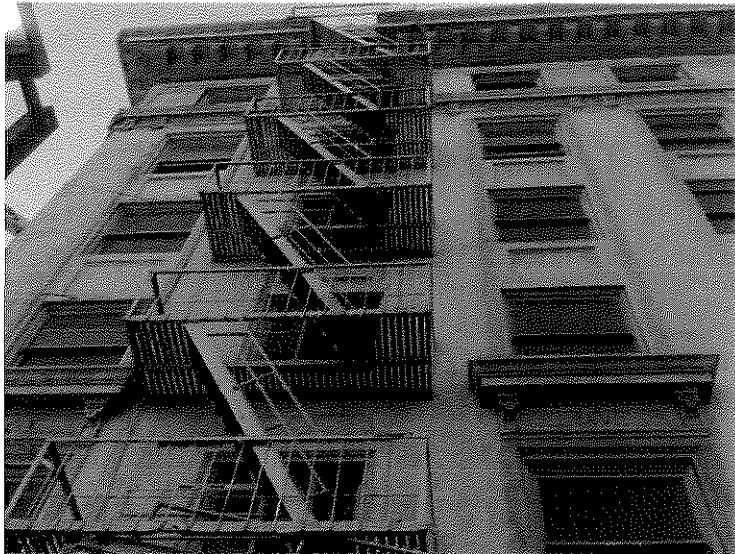
Exterior elevation showing fire escape.

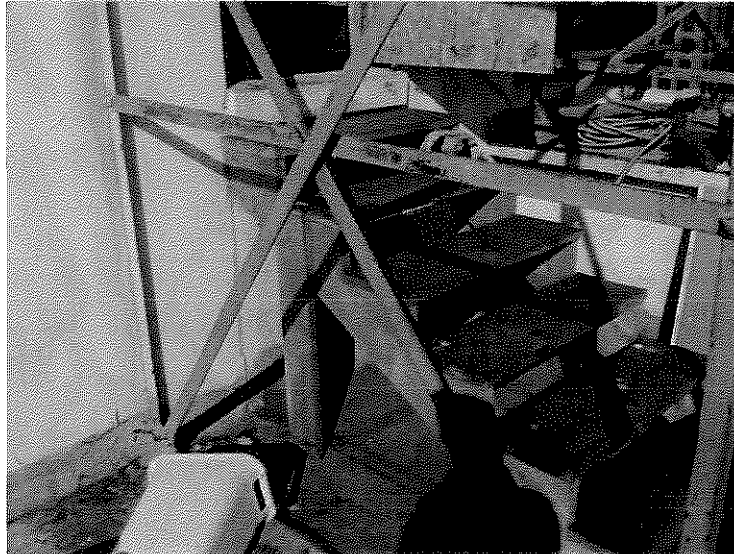
Steps to elevator machine room.

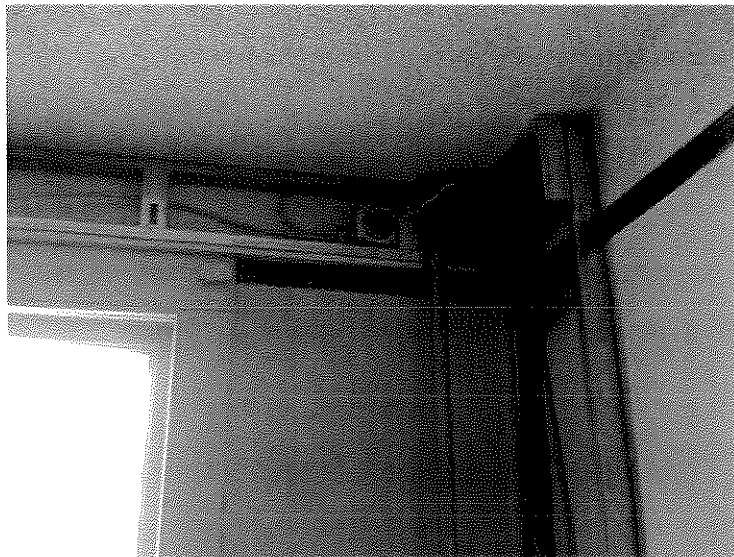
Framing for electrical chase and soffit.

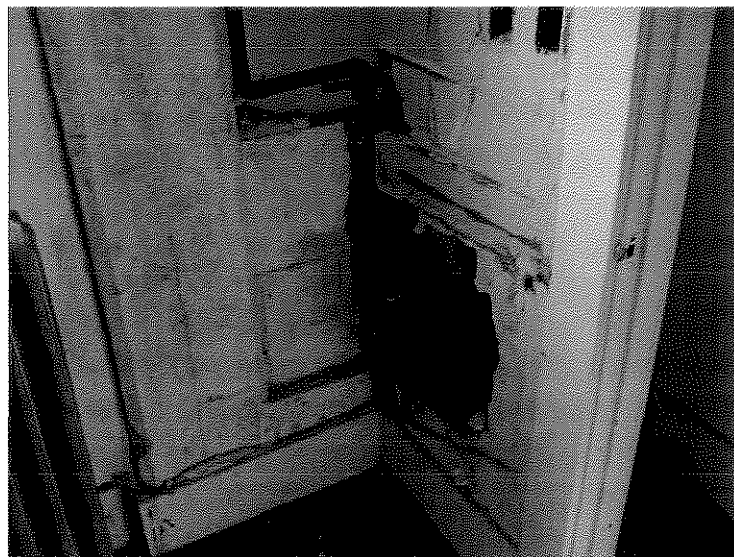
Demolition to replace plumbing waste and vent pipes.

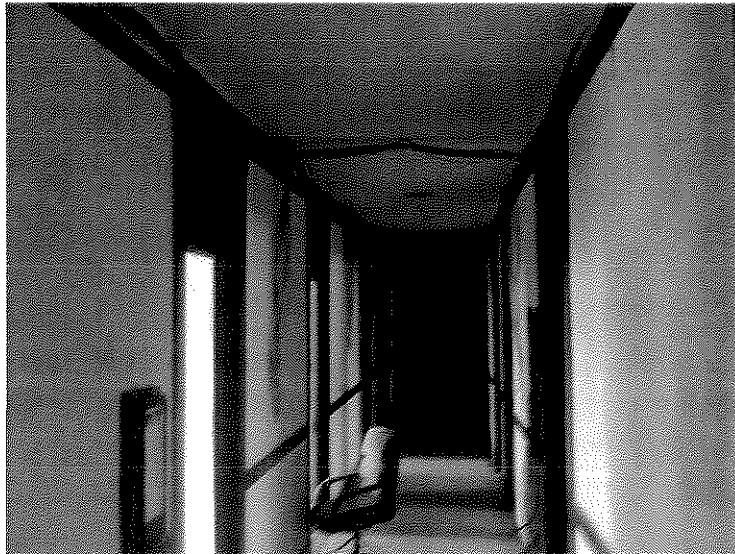
Typical corridor showing electric wiring above doors.

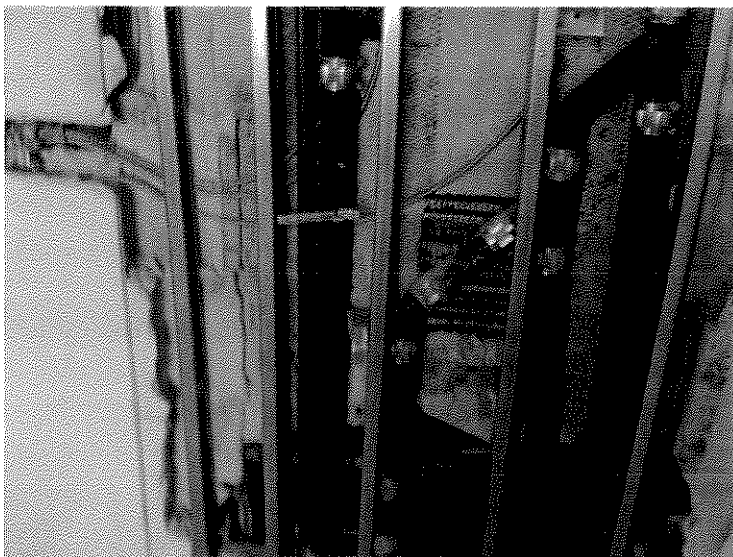
Selective demolition for plumbing waste and vent stacks.

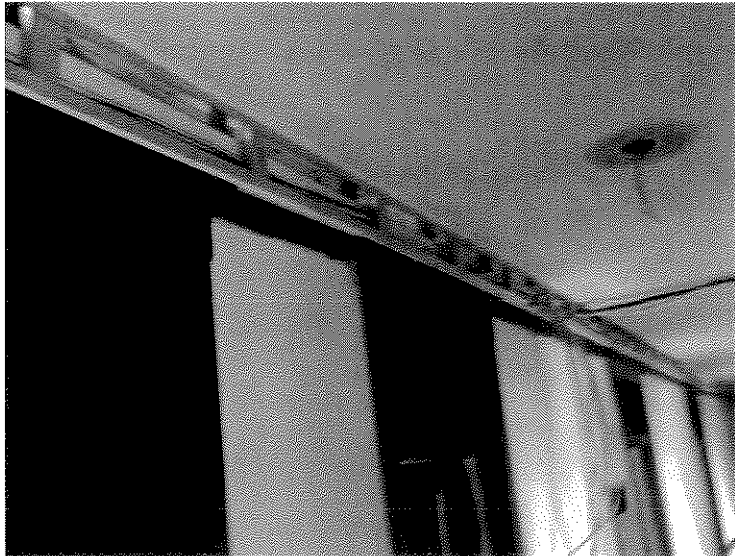
Typical soffit in corridors for electric wiring.

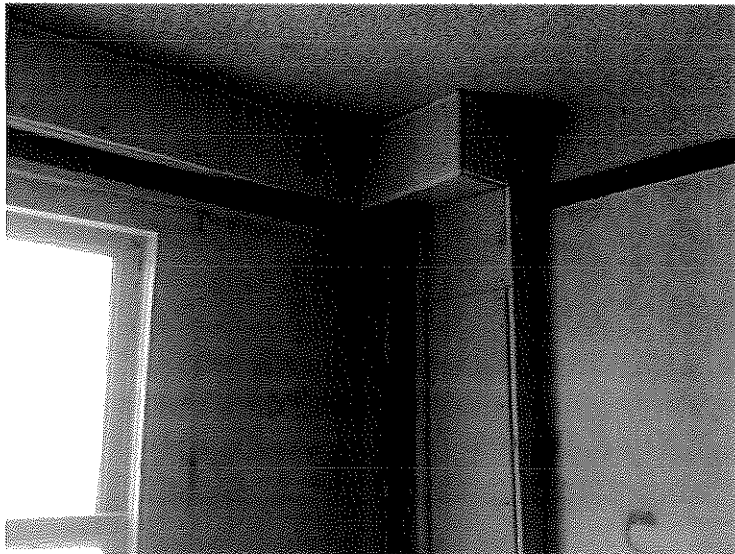
Unit drywalled soffit and chase for electrical rough additions.

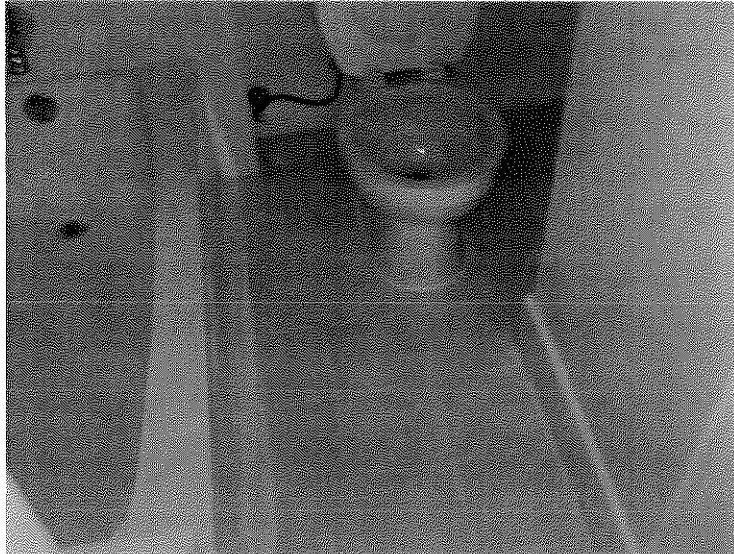
Finished bathroom at model unit.

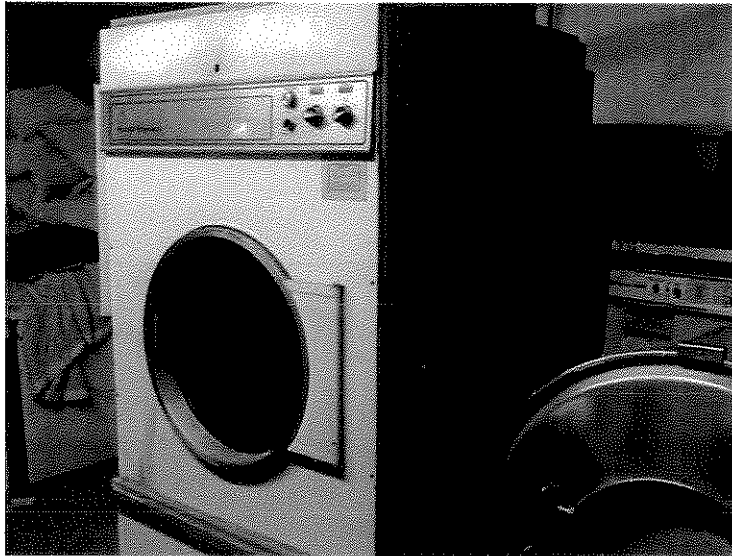
Existing commercial laundry dryer in basement.

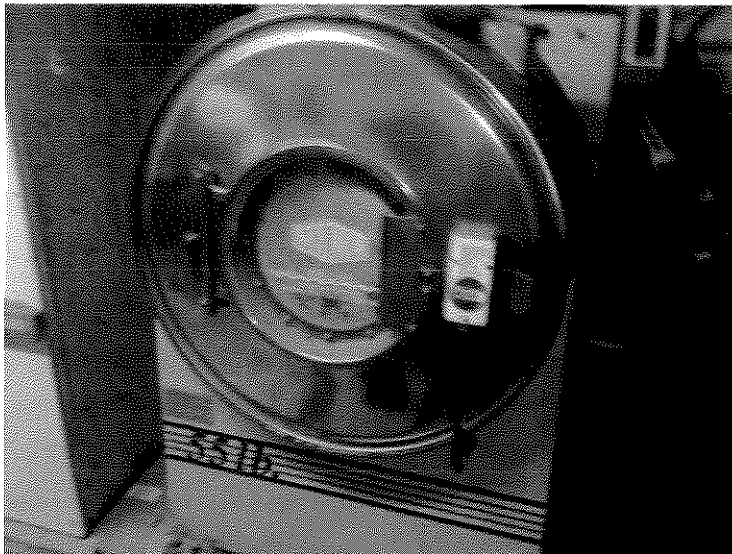
Existing commercial washing machine in basement.

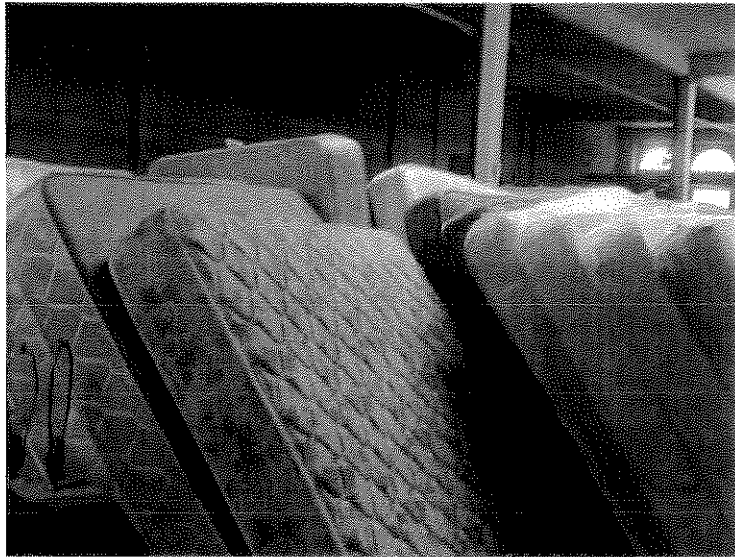
Stored mattresses for units.
