# Tatum Consulting & Management, LLC

Hotel Churchill Construction Status Report  
For the San Diego Housing Commission  
December 9, 2009

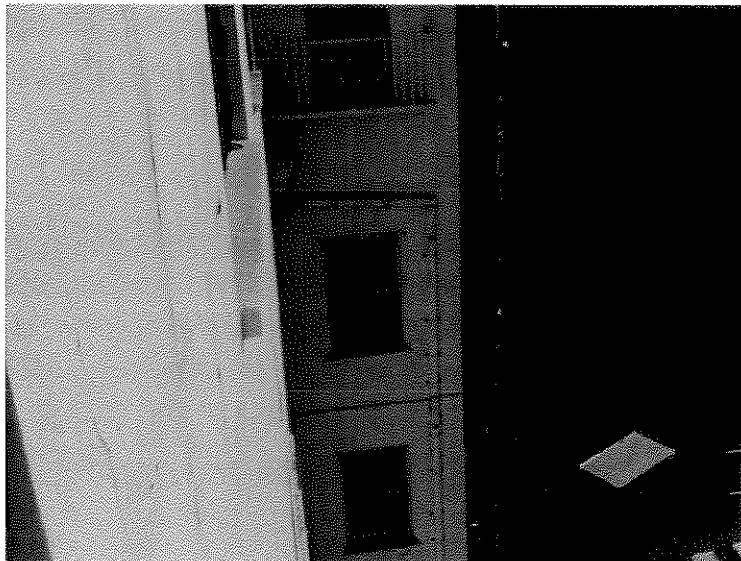
Exterior elevation, showing trash shoot.

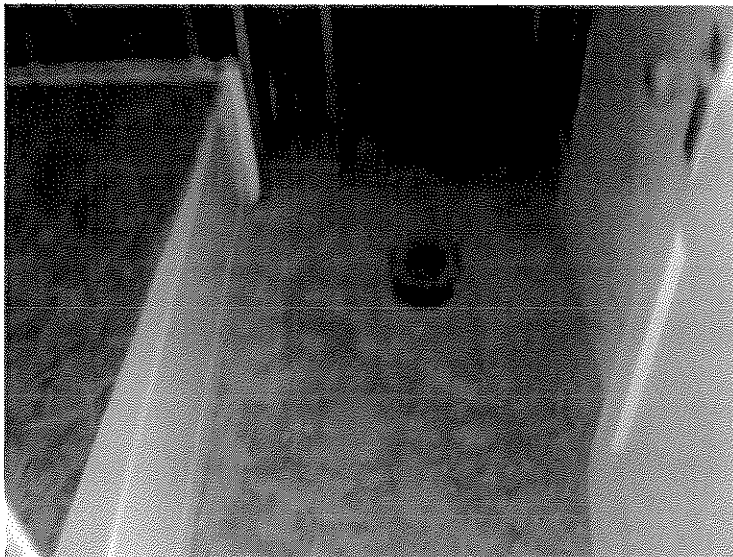
Common area bathroom, toilet location with tub on left.

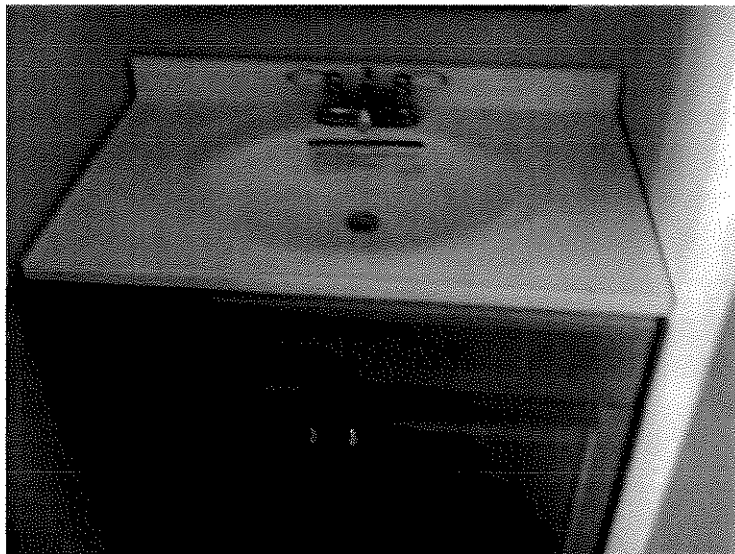
New sink and vanity at model unit.

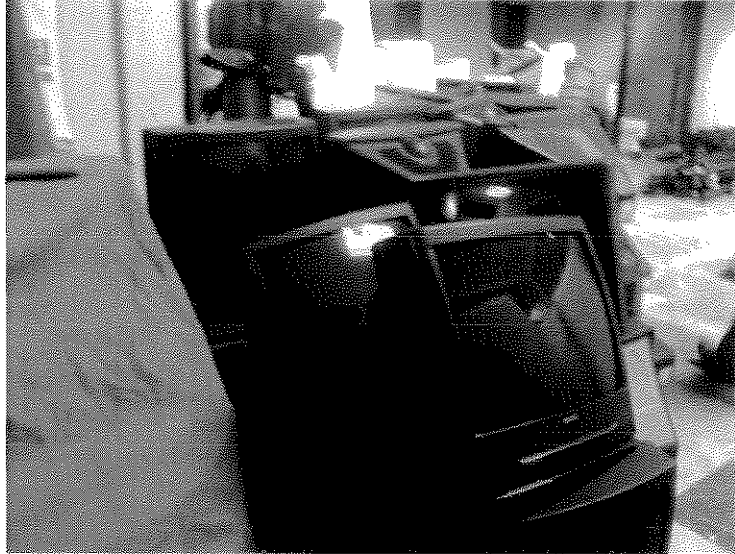
Stored television sets for units.

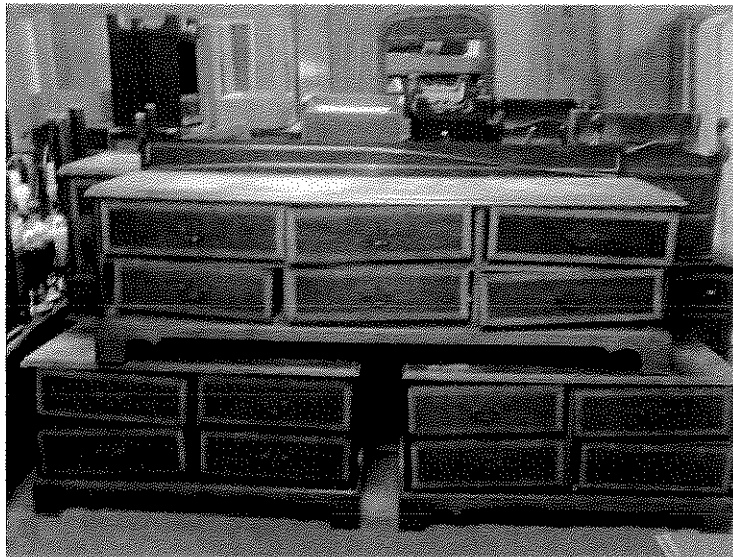
Stored bureaus for units.

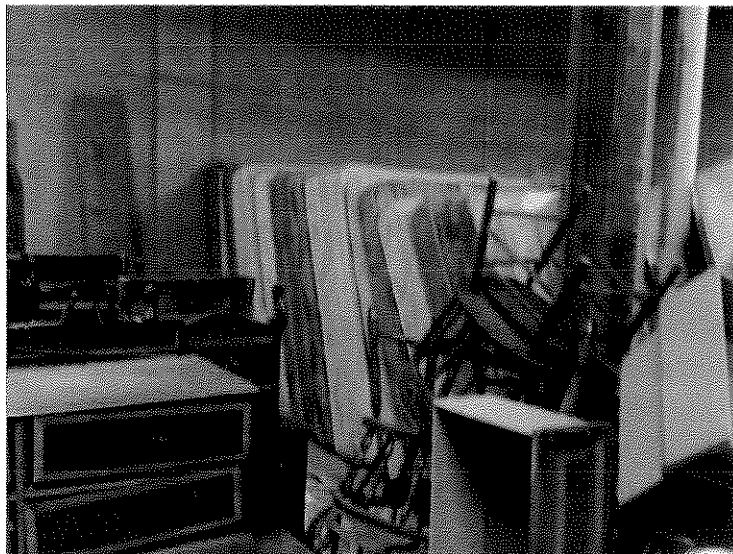
Stored mattresses and chairs for units.

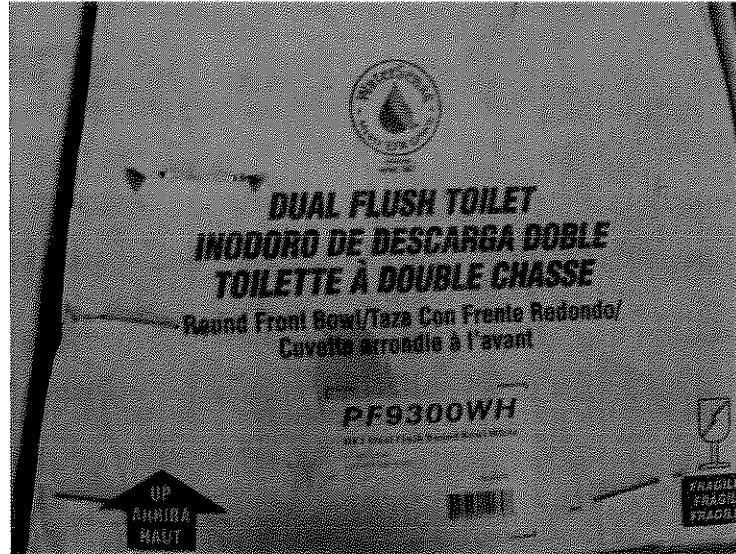
Box of stored toilet.

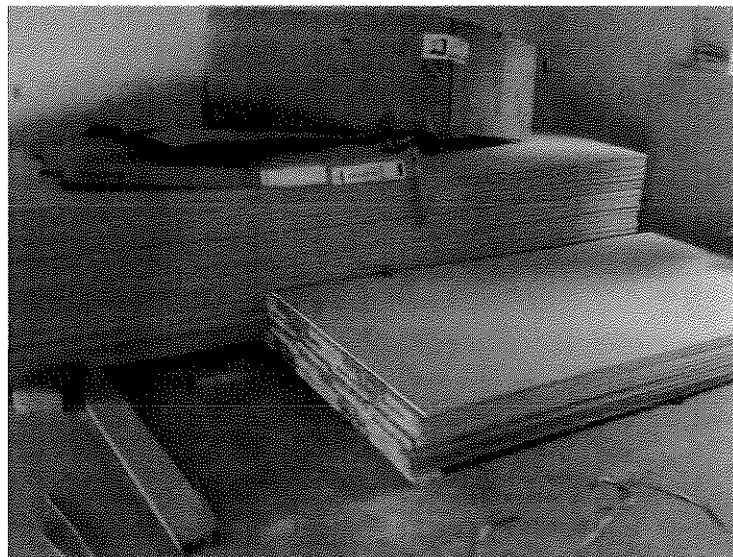
Stored drywall.

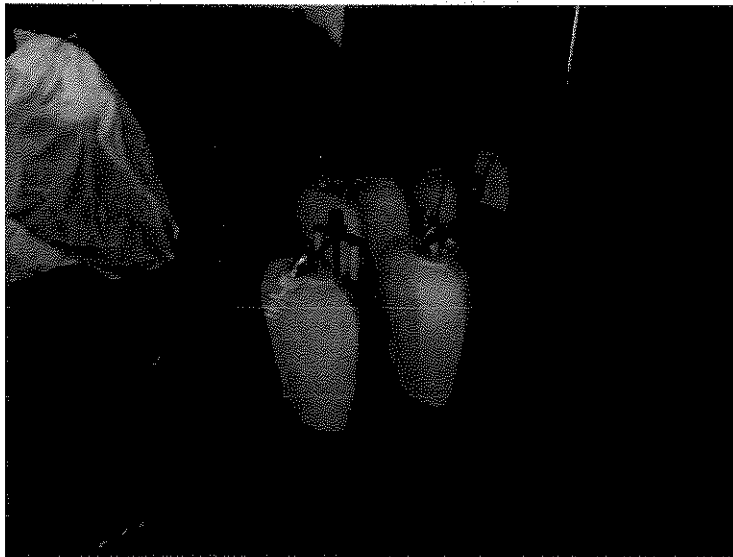
Stored lamps for units.

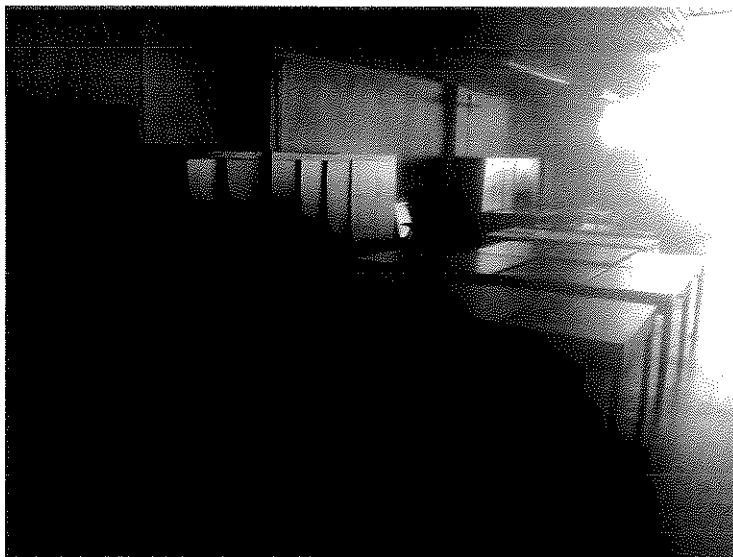
Stored desks and armoires for units.

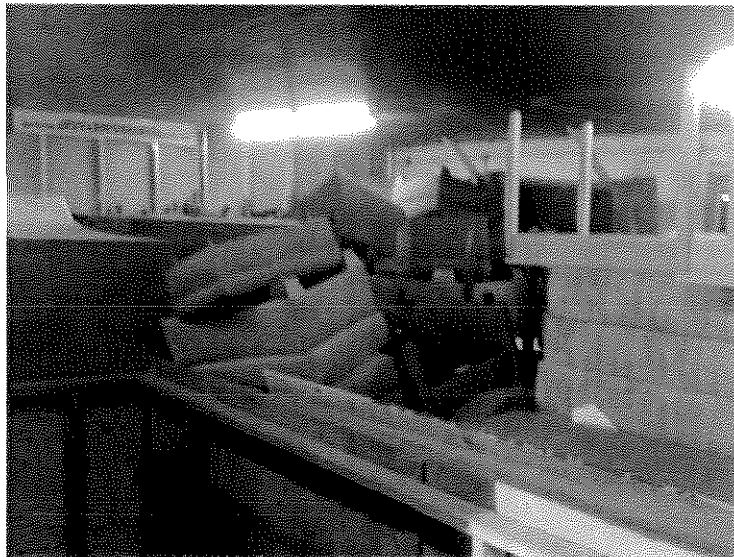
More stored furniture.

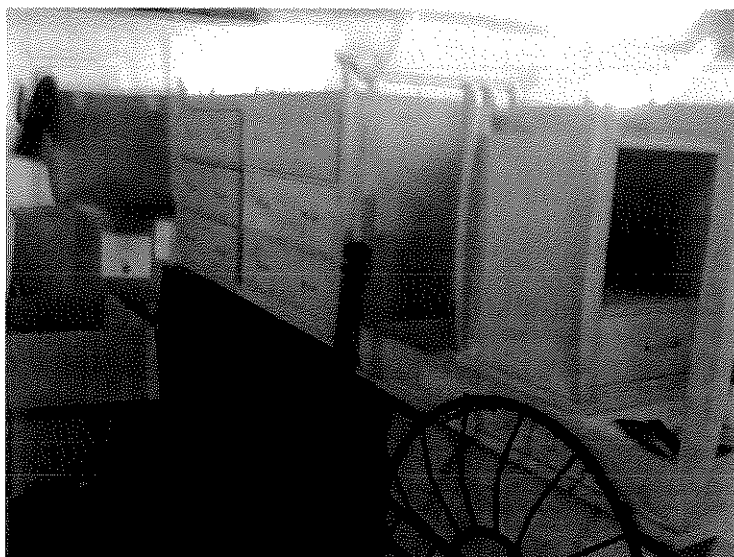
Stored bureaus for units.

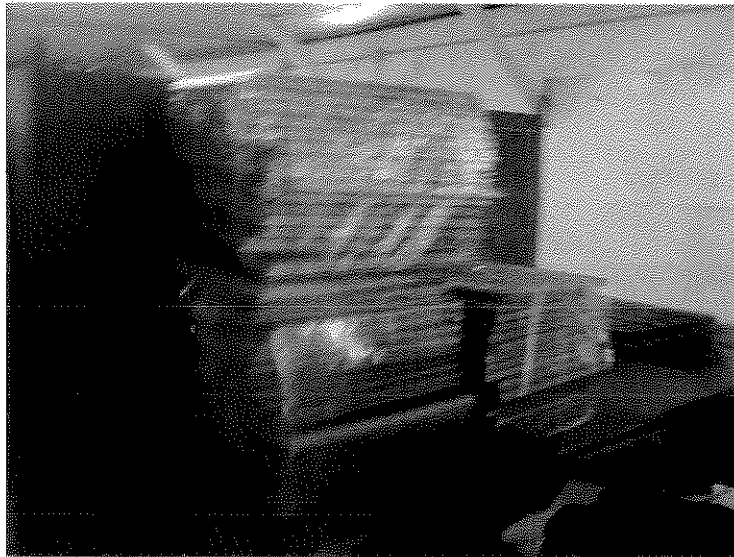
Stored picture frames for units.
